## Crack and Perforated Lining Detection in Irrigation Canals Using YOLOv12n, YOLOv12s, and YOLOv12m

Crack detection; Irrigation canal; Instance segmentation; Perforated lining; YOLOv12.

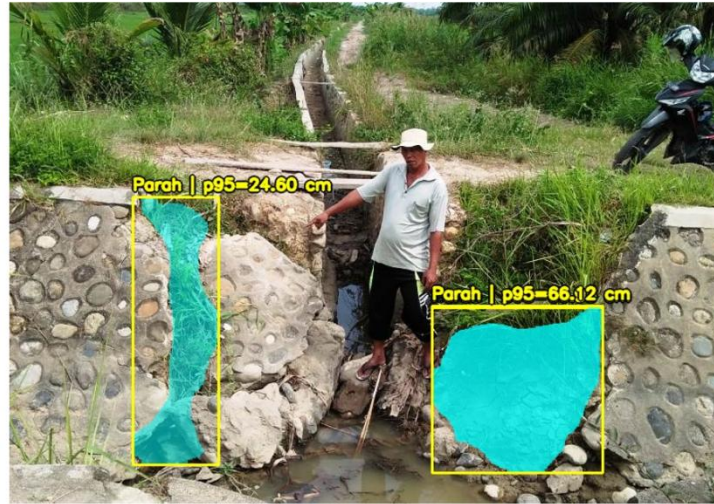
Figure 7. Qualitative mask visualization for canal damage; severity text and centimeter values in the prototype overlay are uncalibrated interface outputs and were not analyzed as study measurements

Qualitative inspection was used to assess whether the predicted masks followed visible canal-damage contours. The examples show that the model can localize irregular regions on lining surfaces, although the visual review is not a substitute for a boundary-accuracy or measurement-validation study. The masks in this experiment are expressed in image pixels. No reference target, camera calibration, or field-verified conversion from pixels to physical area, length, or width was applied. Accordingly, the present results demonstrate localization only; metric measurement and severity classification remain future capabilities that require calibrated acquisition and independent error analysis.

[13]. In the present study, this output can support visual documentation and retrieval of candidate repair locations, but it cannot yet provide physical area, length, width, or severity because scale calibration and measurement-error validation were not performed. A future decision-support workflow would require a known reference dimension or calibrated camera geometry, field measurements, canal material and flow information, maintenance history, and validated decision thresholds [2],[4], [1].

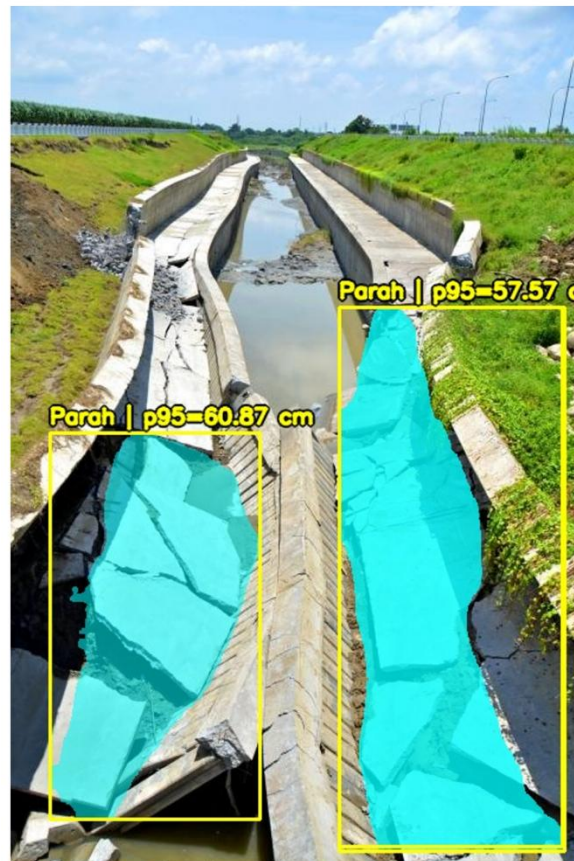
Figure 8. Qualitative mask visualization for large damaged regions; centimeter values in the prototype overlay are uncalibrated and should not be interpreted as validated physical measurements
